A scientist's report on the earthquake and KEK's accelerator test facility

The earthquake takes its toll on one of KEK's hallmark experiments

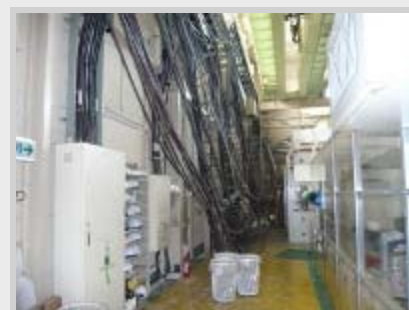
The primary damage to ATF, with fallen cable racks and cables. It will require about a month to repair.

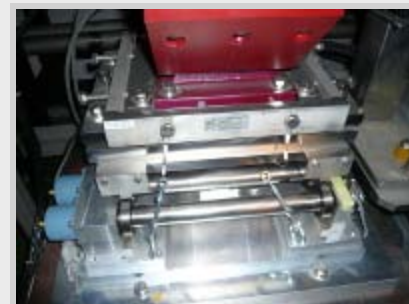
Then, we entered the extraction and ATF2 beam line. All the quadrupole magnets were sitting on the movers, which reassured us very much. They were tied to the support with two wires, which help create an earthquake-proof structure. One of the wires was cut at almost all the quadrupole magnets. The setup worked as expected! No magnets had fallen down. The other instruments looked fine, including wire scanners, optical transition radiation instruments, and the Shintake monitor with lead shields.

The quadrupole magnet sits on the mover. One of the wires was cut. The earthquake-proof apparatus worked as designed.
